Rimkus Consulting Group, Inc.
Eight Greenway Plaza, Suite 500
Houston, TX 77046
(800) 580-3228 Telephone
(713) 623-4357 Facsimile

Re: RCG File No: 11009971
LLV Number: 0209452
VMF Location: 1530 Greensmark Drive in Houston, Texas
Subject: Final Report

Rimkus Consulting Group, Inc. was retained to examine LLV 0209452, VIN 1GBCS10E4M2908832. The fire occurred on June 13, 2016 at around 12:30 P.M. the operator of the vehicle at the time of the fire, was unavailable for interview but reportedly stated the vehicle's engine died while delivering mail on his route and backfired during subsequent attempts to restart it. Soon thereafter, smoke was observed from beneath the hood as well as flames.

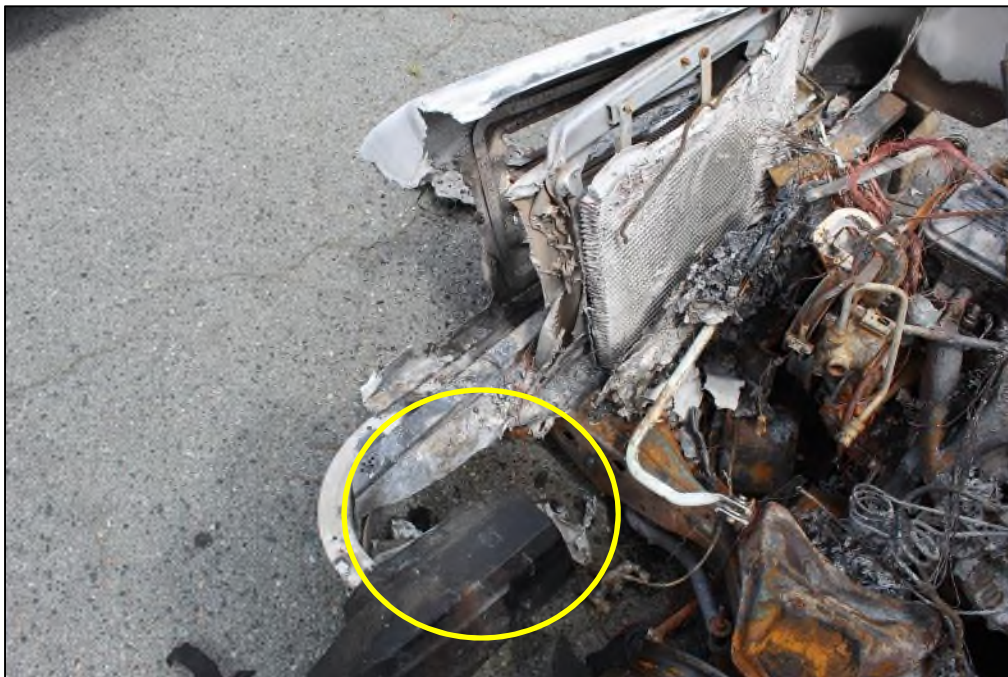
Photograph 8

Location behind the left headlight assembly where the charcoal canister for the EVAP system had been located.

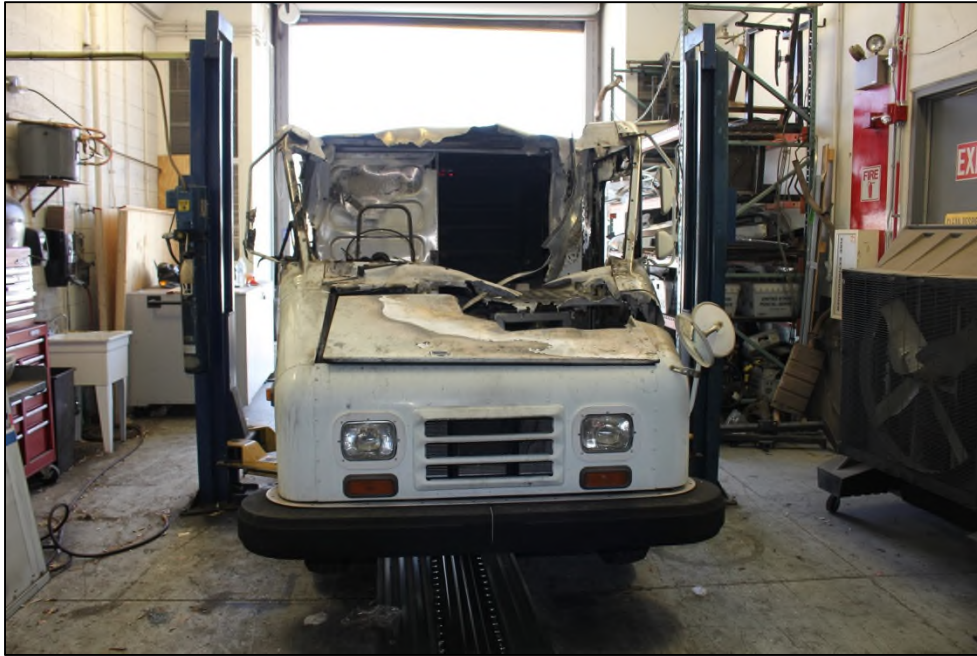
Photograph 1

View of the fire-related damage to the exterior of the LLV 4318404.

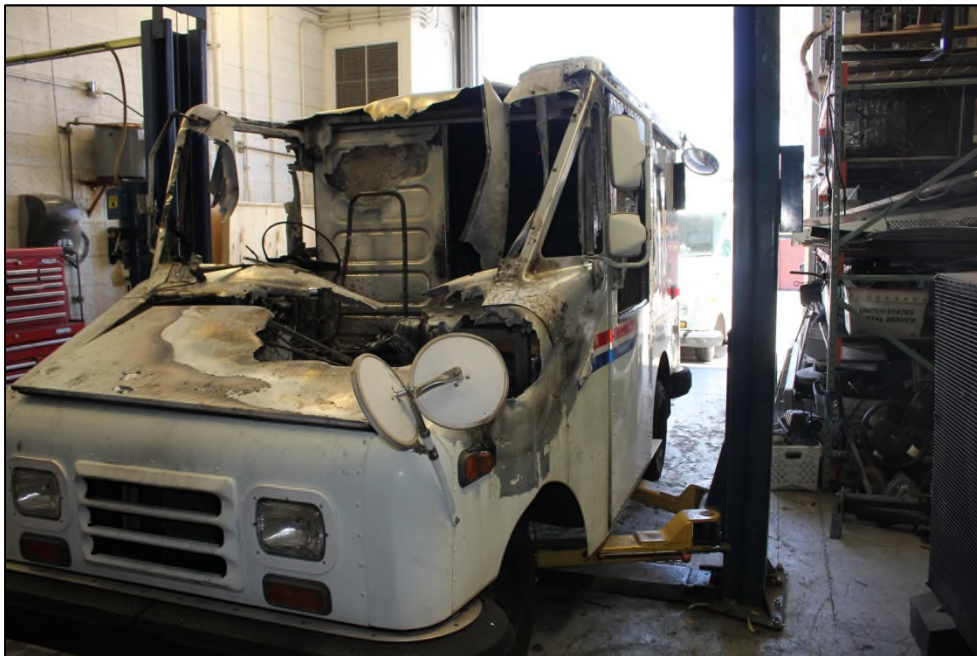
Photograph 2

View of the fire-related damage to the exterior of the LLV 4318404.

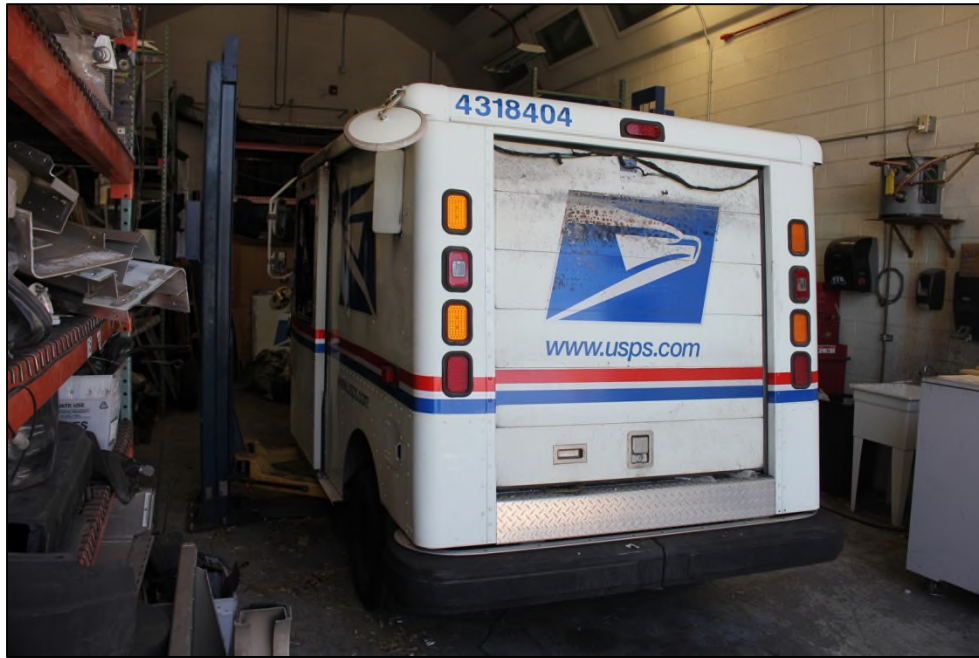
Photograph 3

View of the fire-related damage to the exterior of the LLV 4318404.

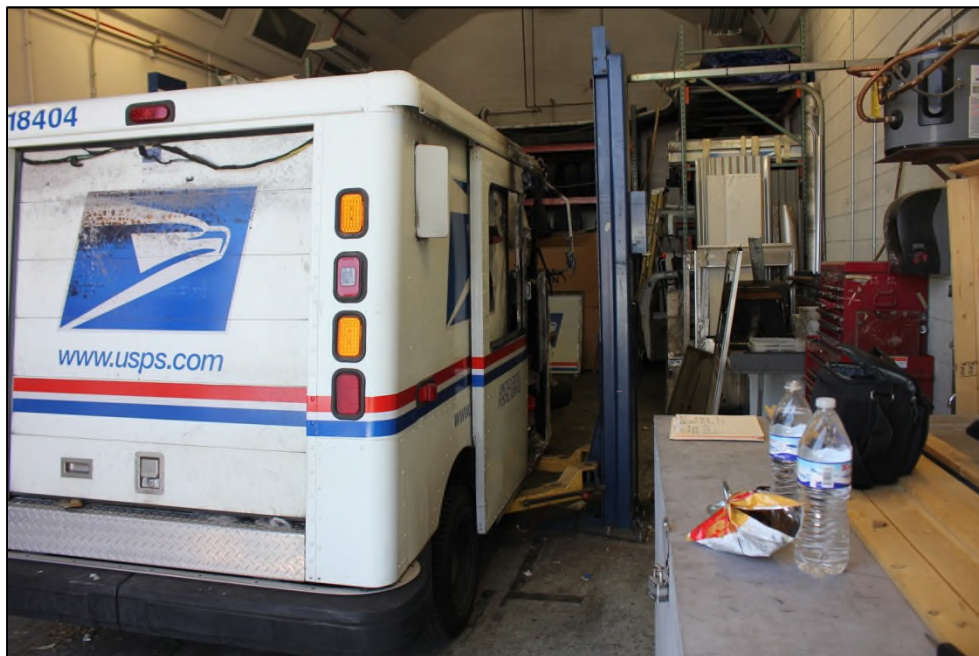
Photograph 4

View of the fire-related damage to the exterior of the LLV 4318404.

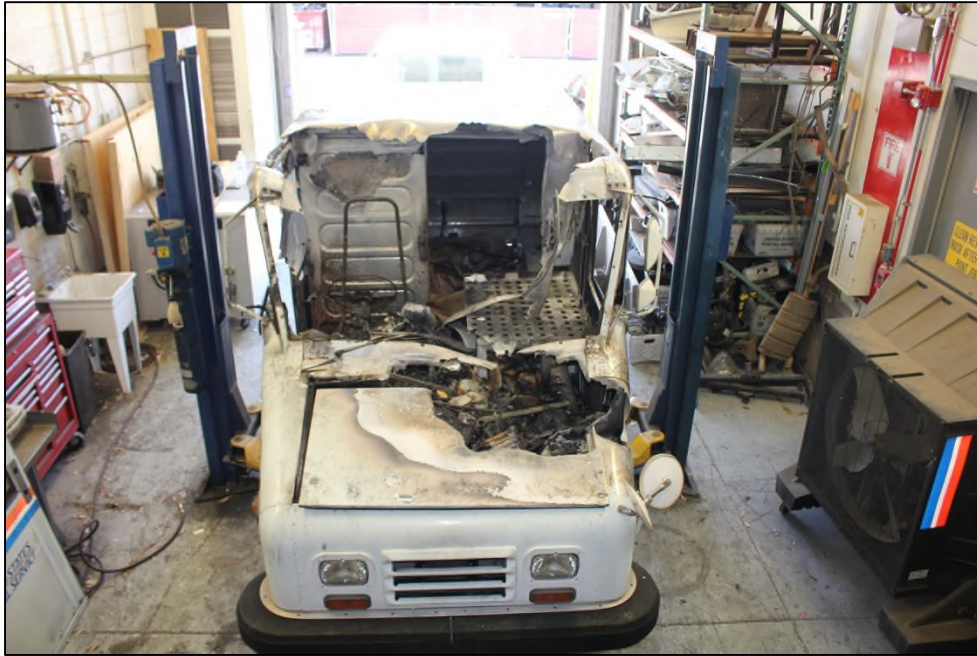
Photograph 5

View of the fire-related damage to the exterior of the LLV 4318404.

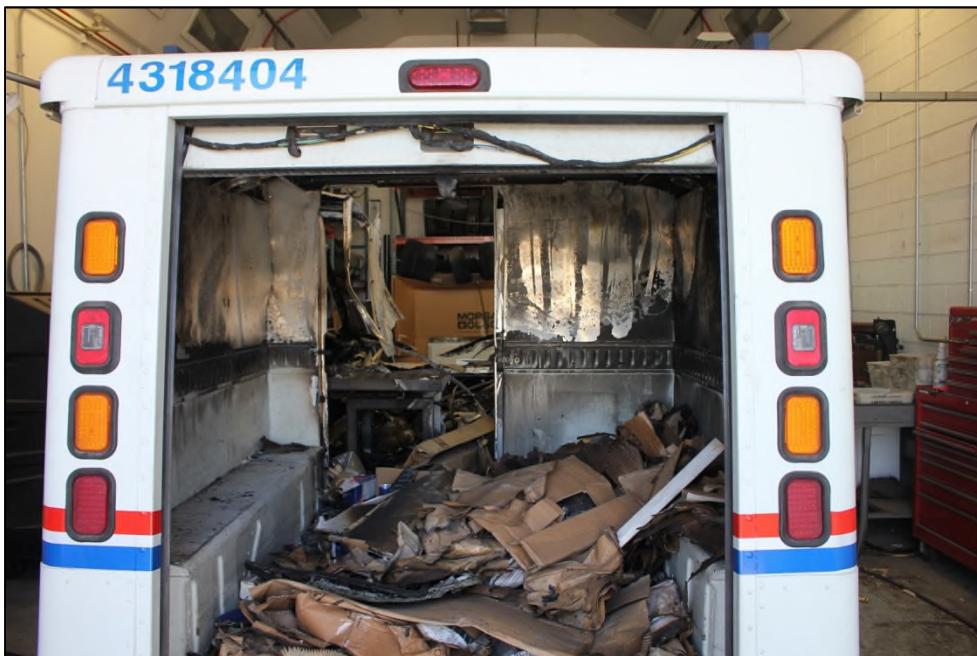
Photograph 6

View of the fire-related damage to the interior cargo compartment of the LLV 4318404.

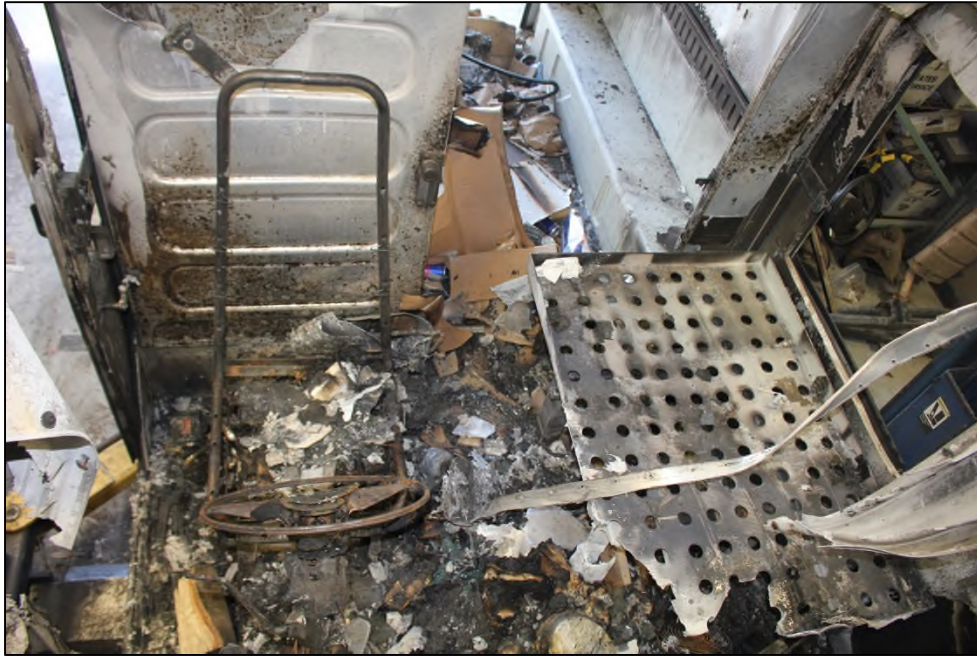
Photograph 7

View of the fire-related damage to the operator's compartment of the LLV 4318404.

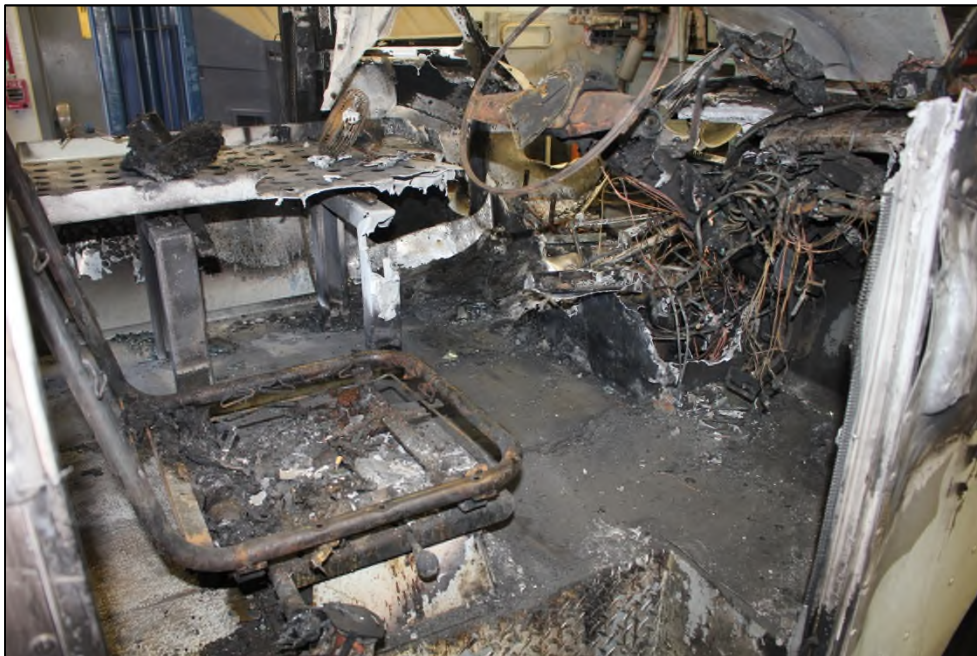
Photograph 8

View of the fire-related damage to the operator's compartment of the LLV 4318404.

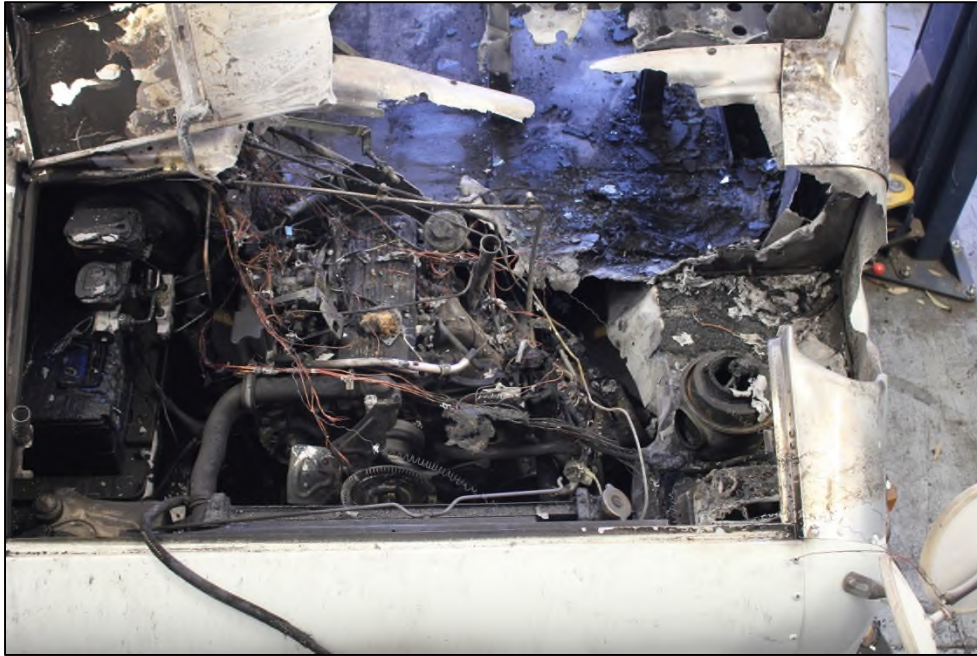
Photograph 9

View of the fire-related damage to the engine compartment of the LLV 4318404.

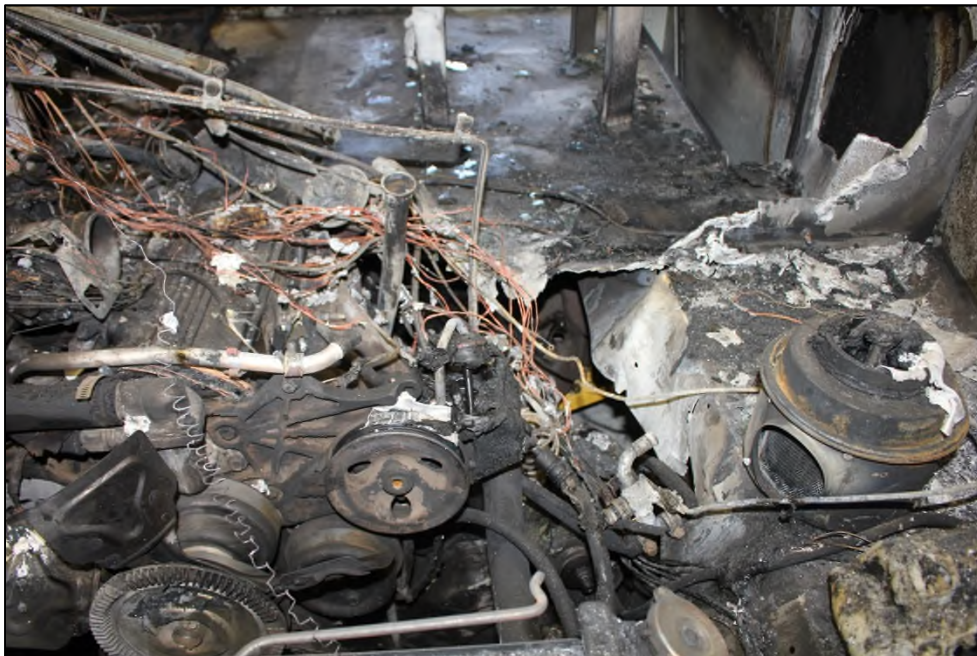
Photograph 10

View of the fire-related damage to the engine compartment of the LLV 4318404.

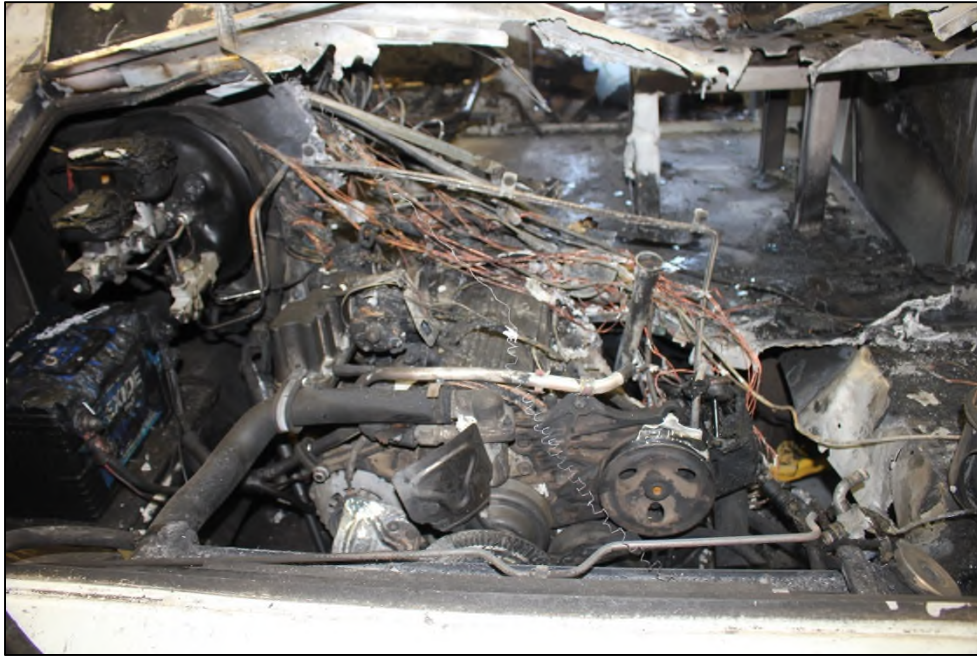
Photograph 11

View of the fire-related damage to the engine compartment of the LLV 4318404.

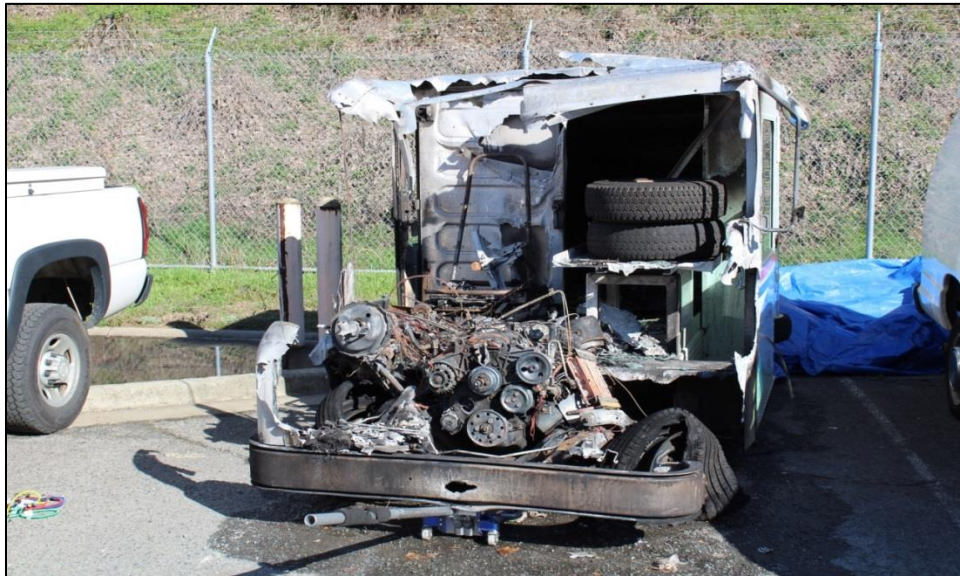
Severe fire damage to the engine compartment and mail side compartment.

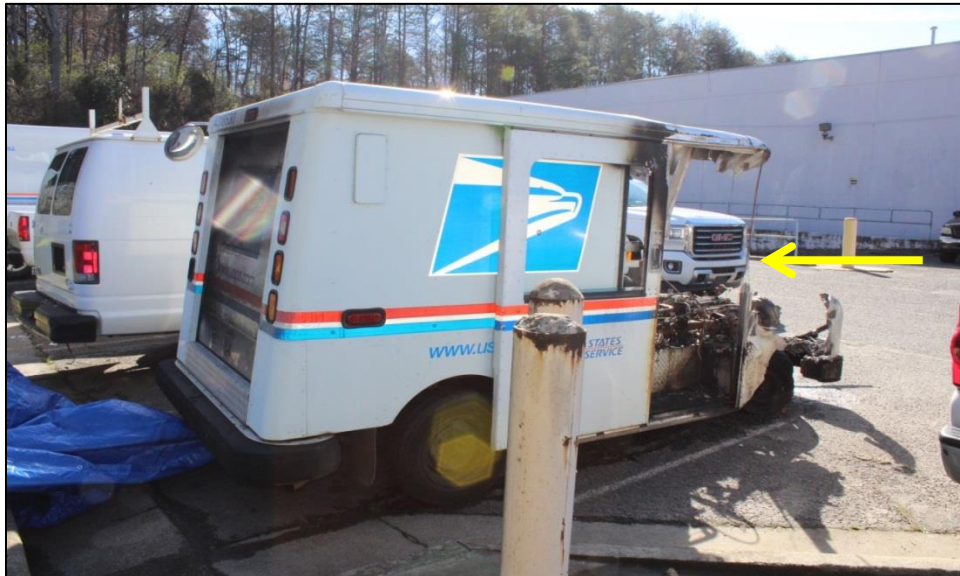
Photograph 3

Driver's side of the vehicle; observe the progression of the burn patterns from the front towards the rear.

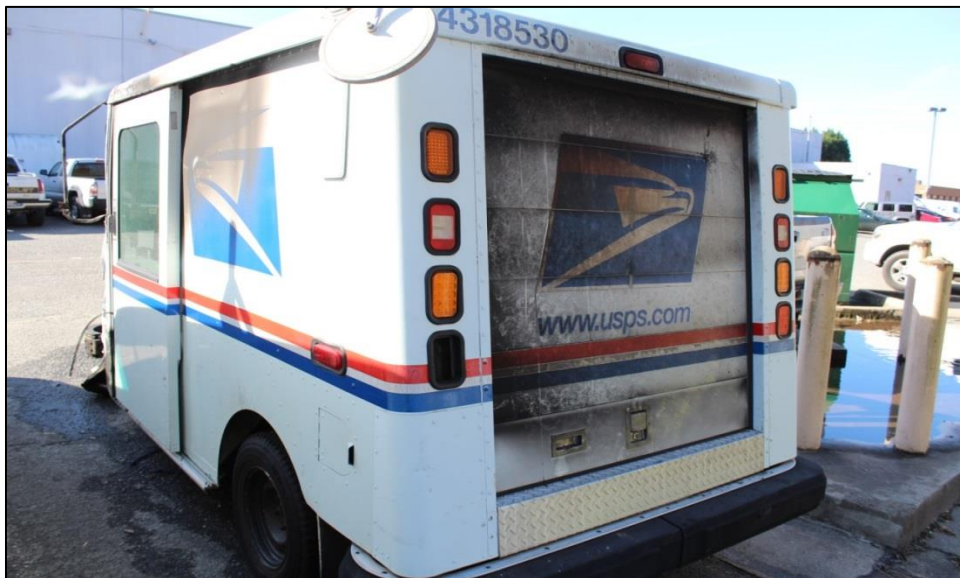
Photograph 4

The mail side of the vehicle; minimal fire damage.

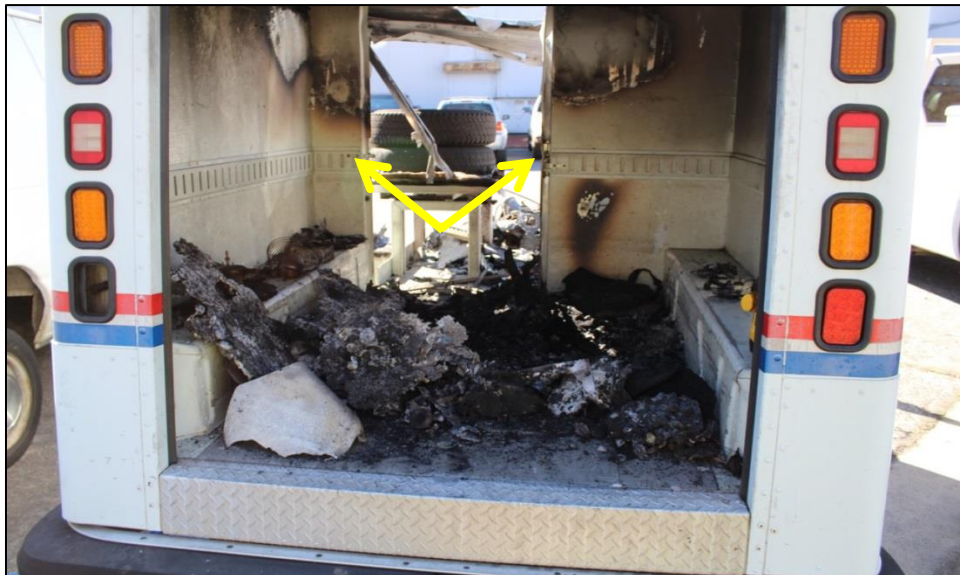
Photograph 6

The rear cargo area, observe the progression of the burn patterns into the area.

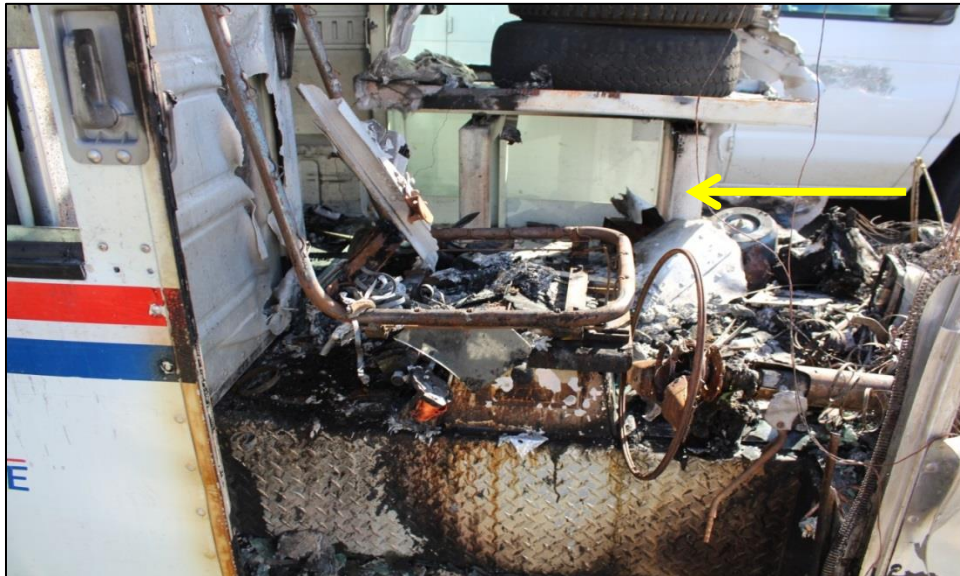
Photograph 7

The mail side compartment, driver's seat and steering column; observe the progression of the burn patterns from the front towards the rear.

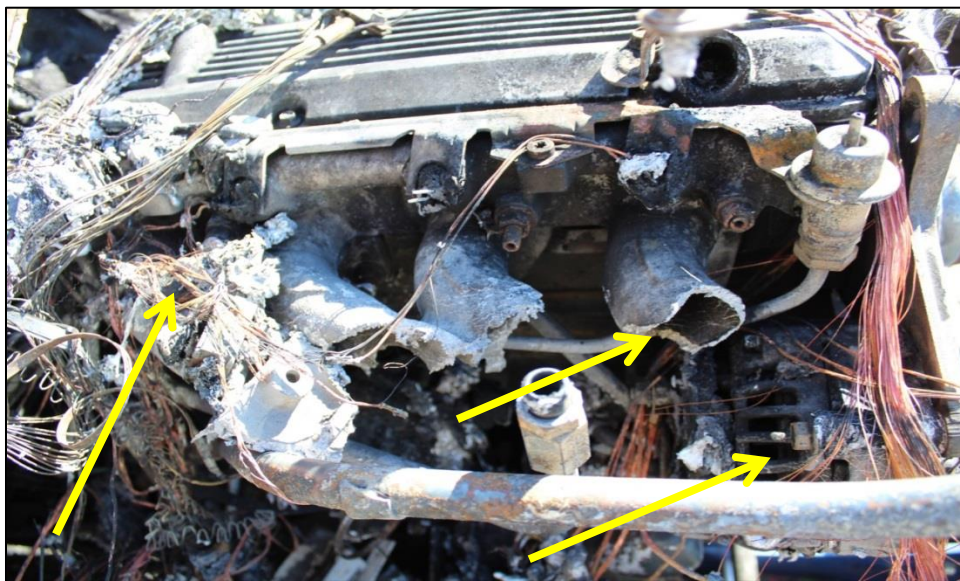
Photograph 12

The driver's side of the engine compartment; observe the severe fire damage to the exhaust manifold, ignition components, and the alternator housing.

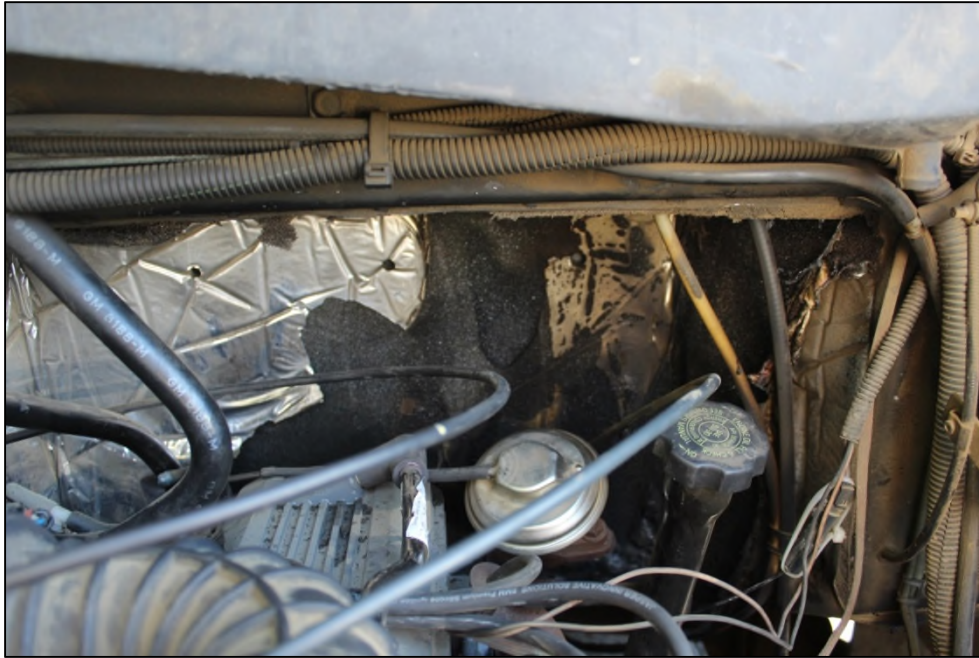
Photograph 3

Heatshield on firewall of engine compartment affected by heat and fire.

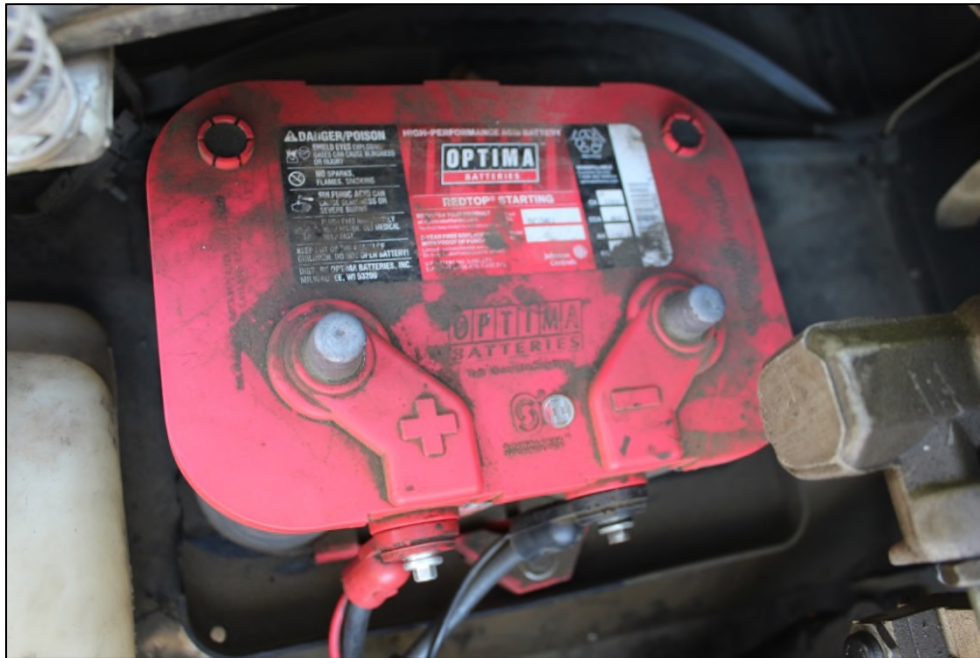
found intact; no adverse electrical activity was observed. The battery, battery terminals, and battery cables were eliminated as a cause of the fire.

Photograph 5
The battery (undamaged).

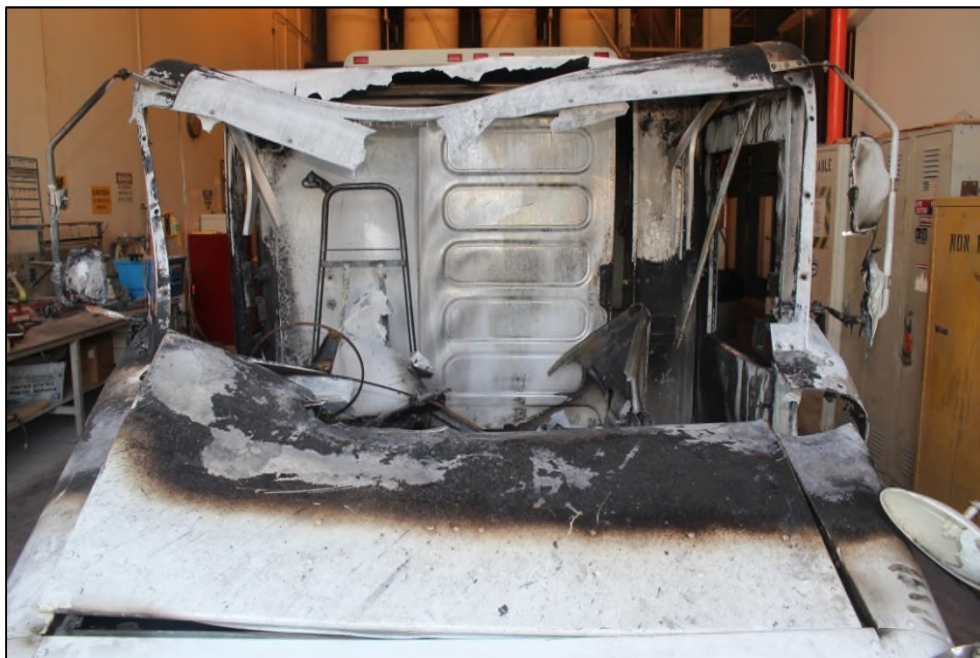
Photograph 2
Hood indicates fire/heat at rear of engine compartment.

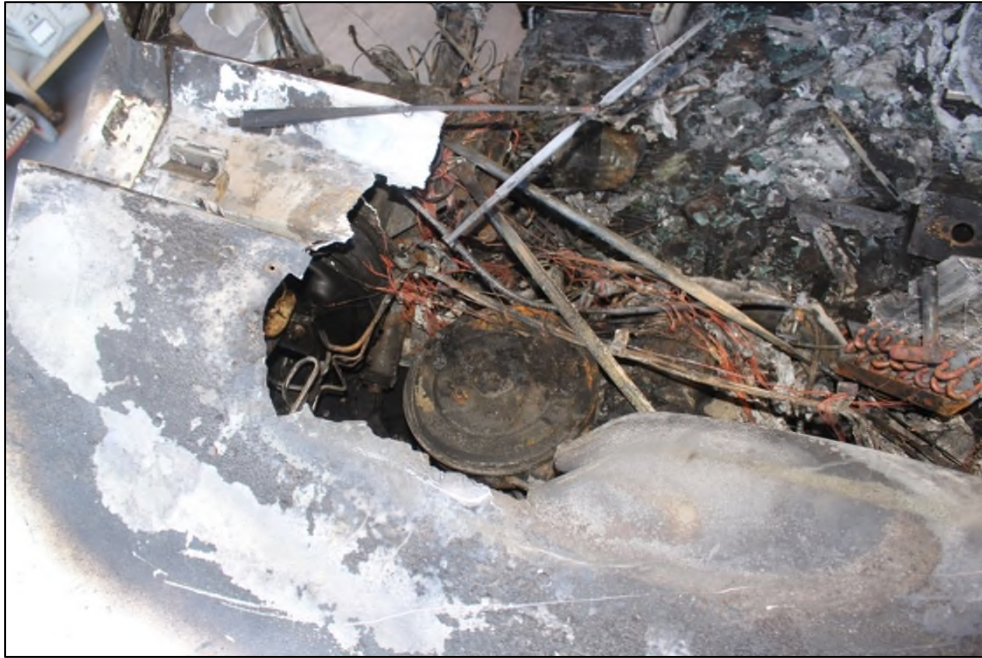
Photograph 3

Hood melted above engine air filter.

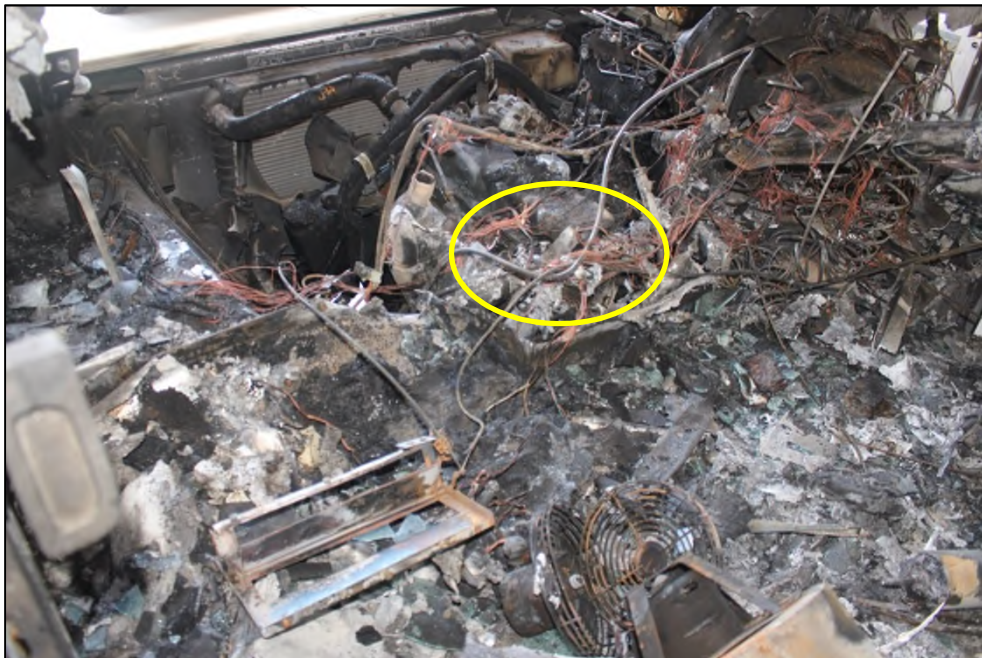
Photograph 4

Origin area high at rear of engine compartment, Yellow circle.

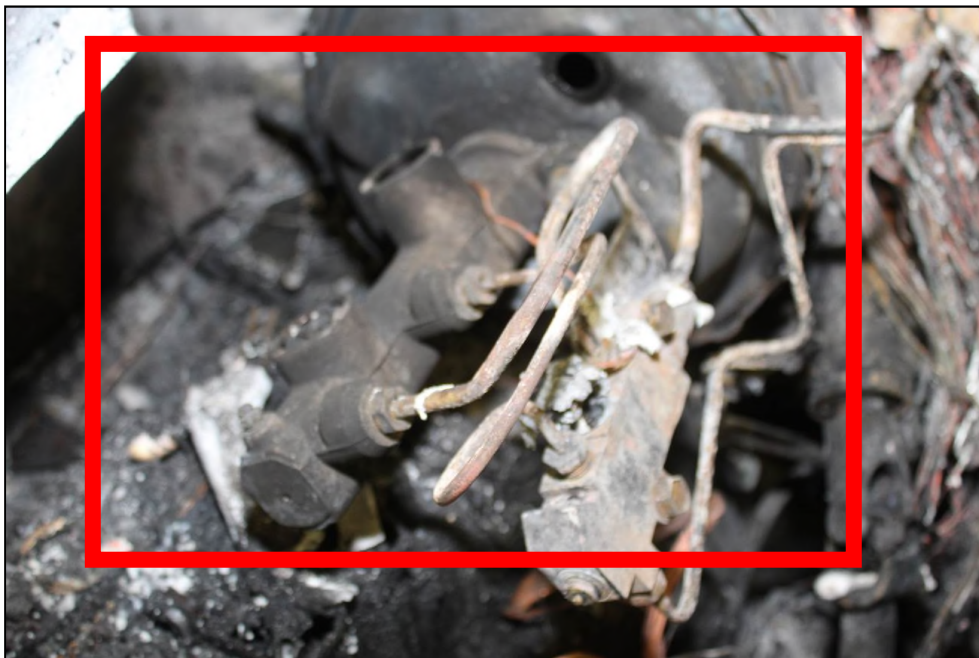
Photograph 4

Remains of the brake vacuum pump.

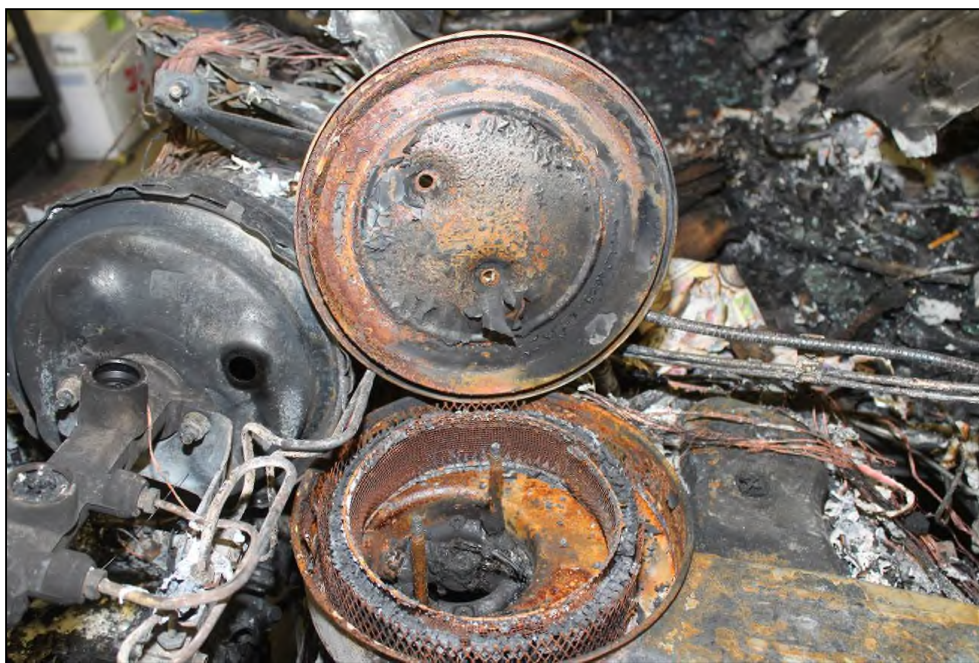
Photograph 5

Remains of the air filter canister.

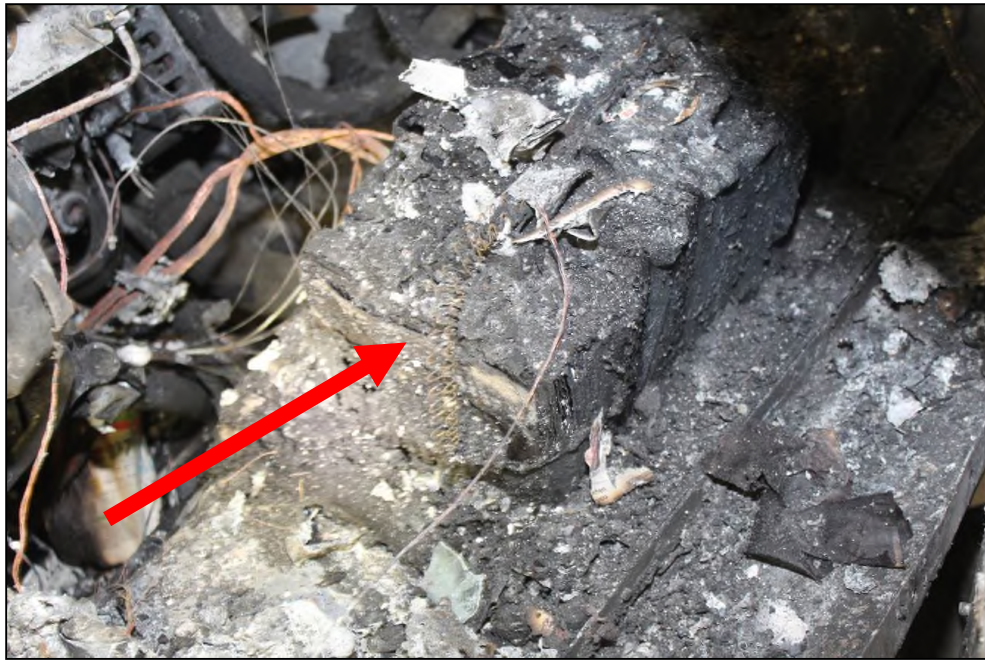
Photograph 7
Remains of the battery.

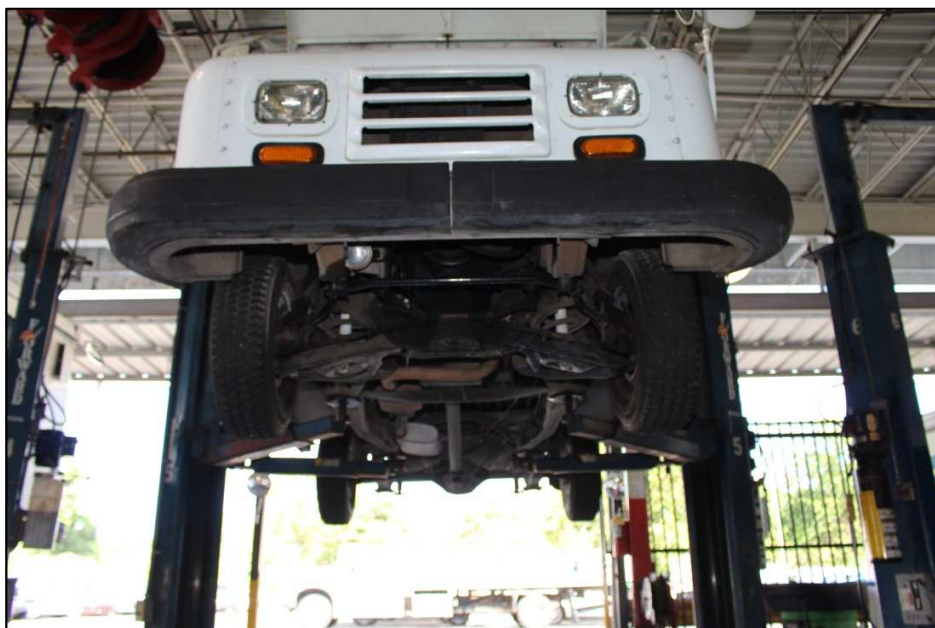
Photograph 2
Undercarriage examination was conducted and fire damaged emergency brake cables were found.

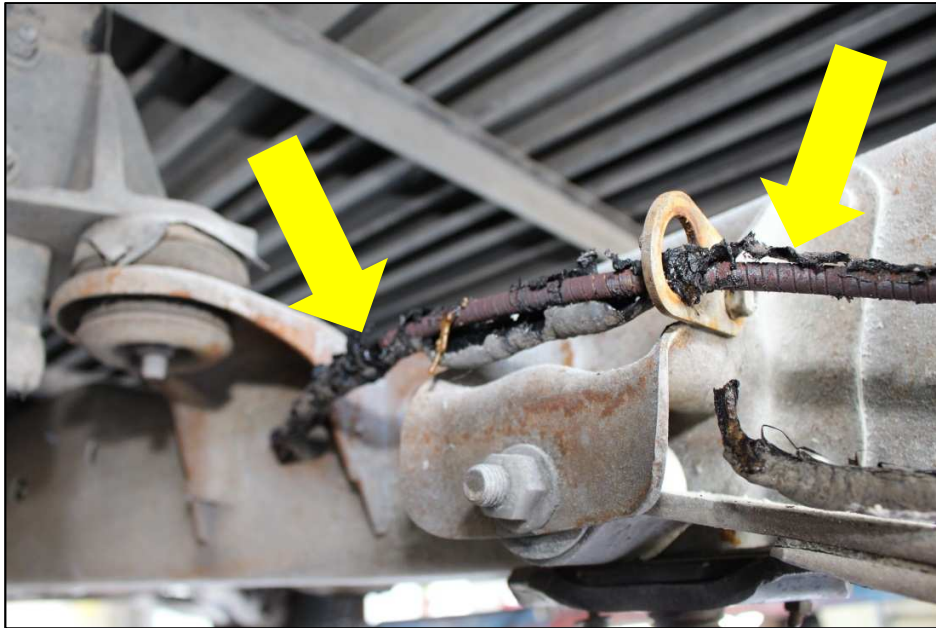
Photograph 3

Melted plastic sheathing of the emergency brake cable was observed during the undercarriage examination.

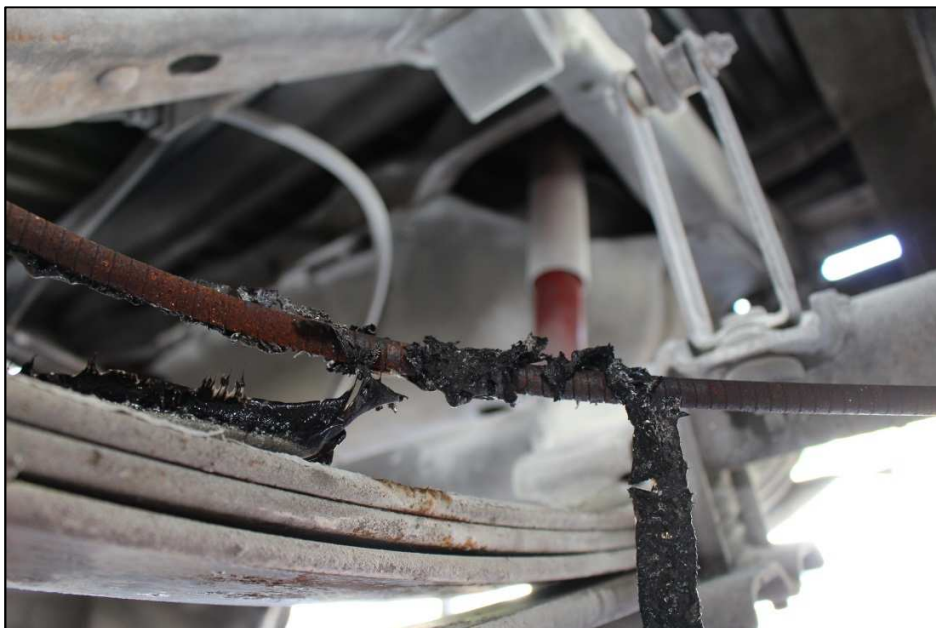
Photograph 4

View of fire damage to emergency brake cable attached to the right rear wheel.

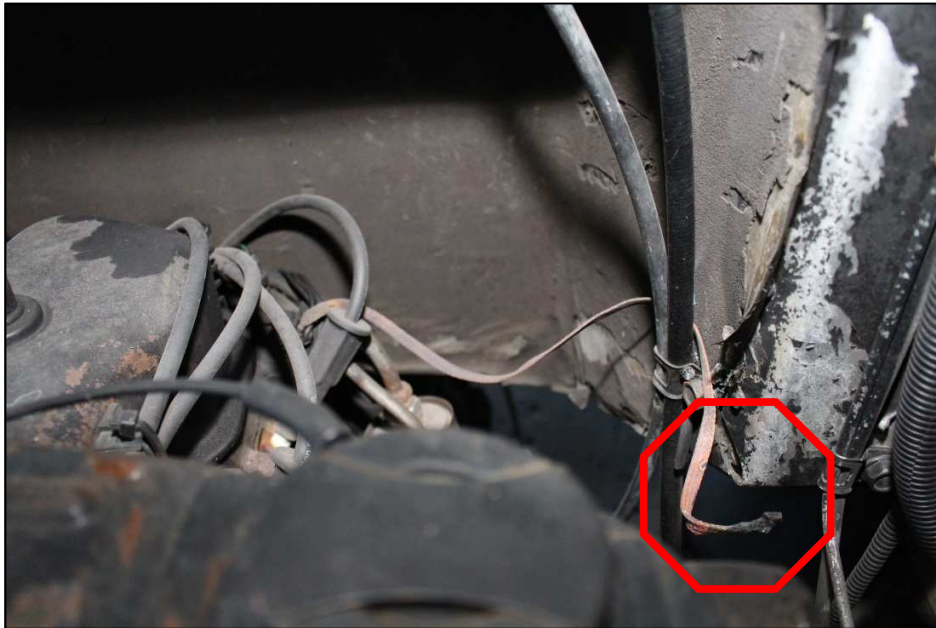
Photograph 5

Grounding strap on left side of the engine compartment was found severed from the connector attached to the vehicle frame.

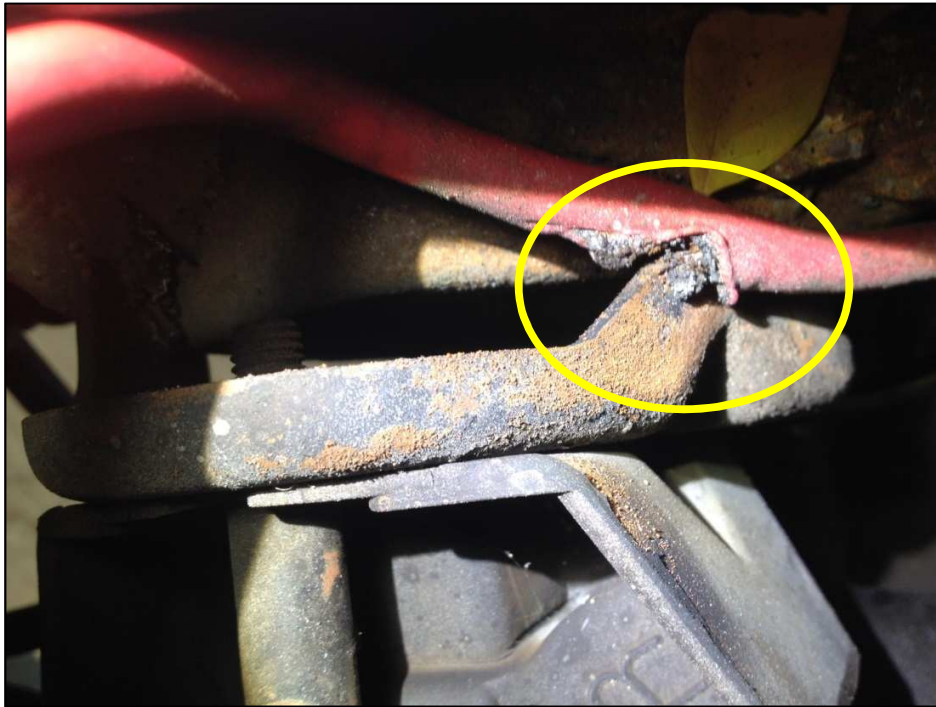
Photograph 7

The large positive conductor was found pinched between the motor mount and the vehicle frame.

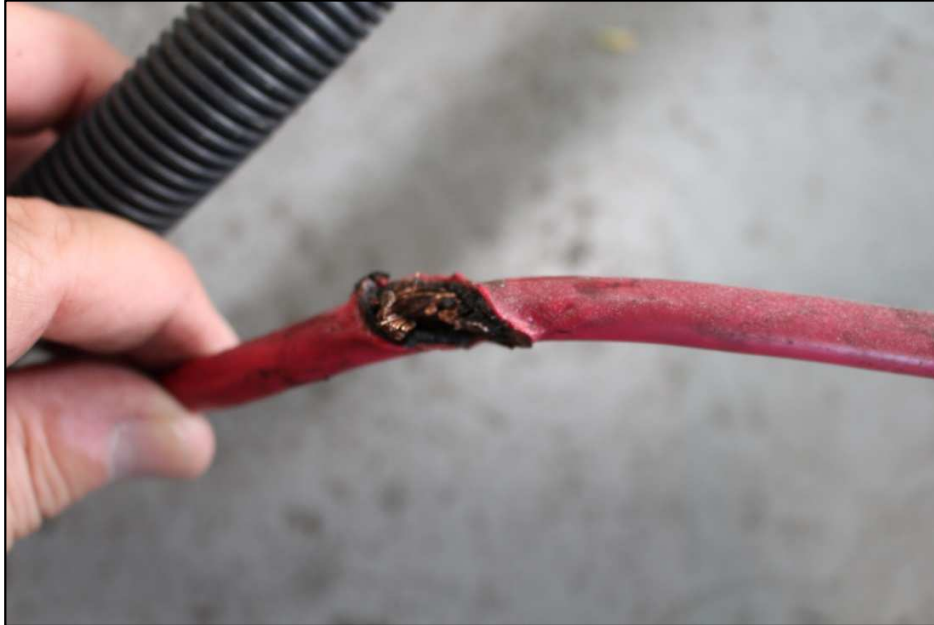
Photograph 9

Close-up view of the damaged positive battery cable.

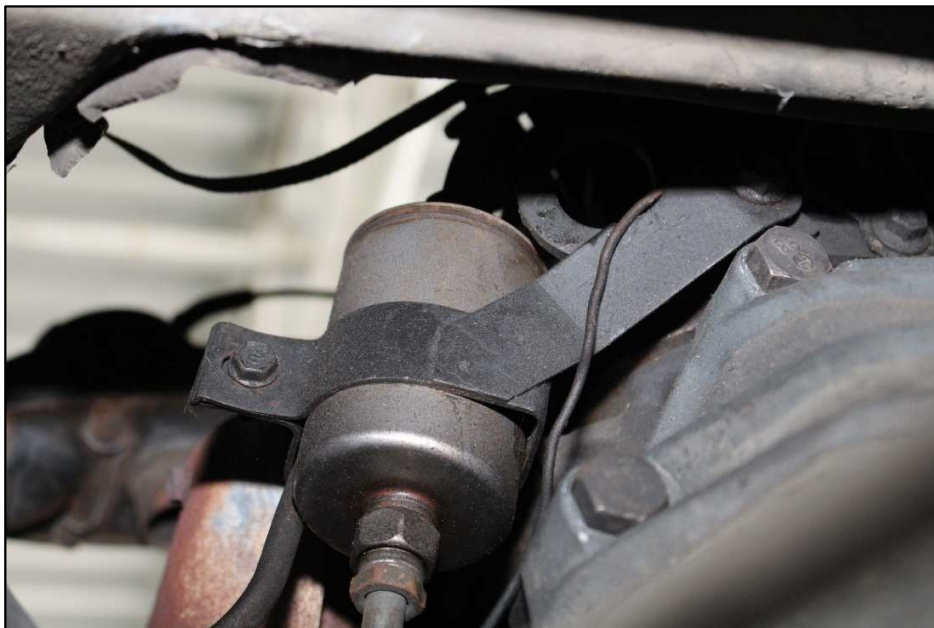
Photograph 10

The fuel filter was mounted in the rear of the engine compartment and displayed no fire damage.

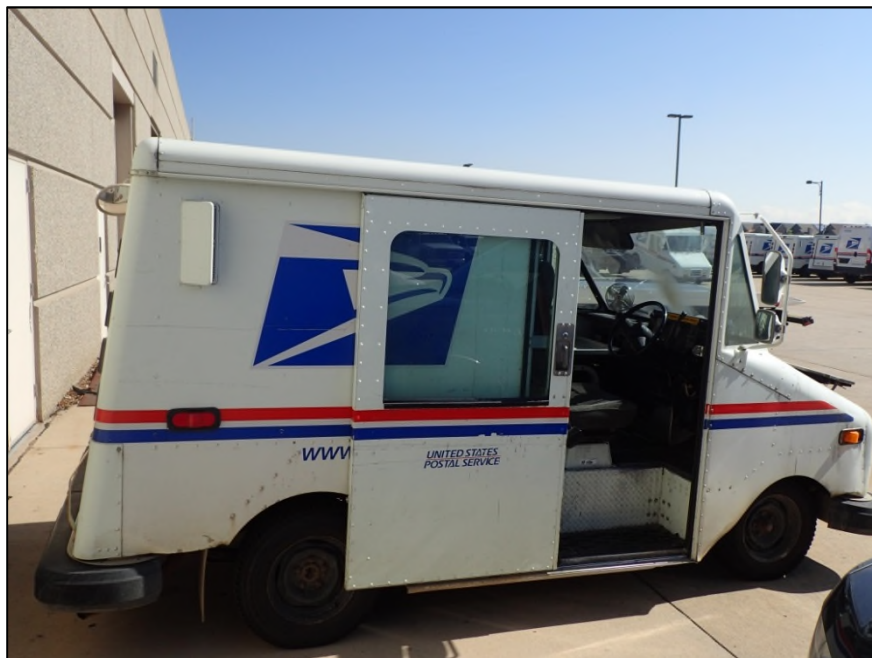
Photograph 4

The driver side exterior of the vehicle.

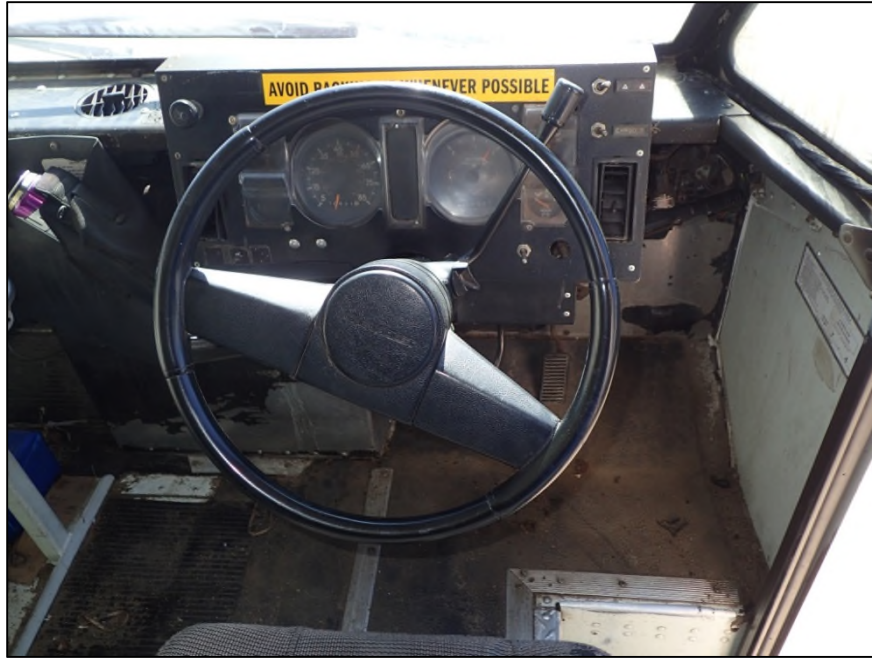
Photograph 5

The driver's side of the driver's compartment.

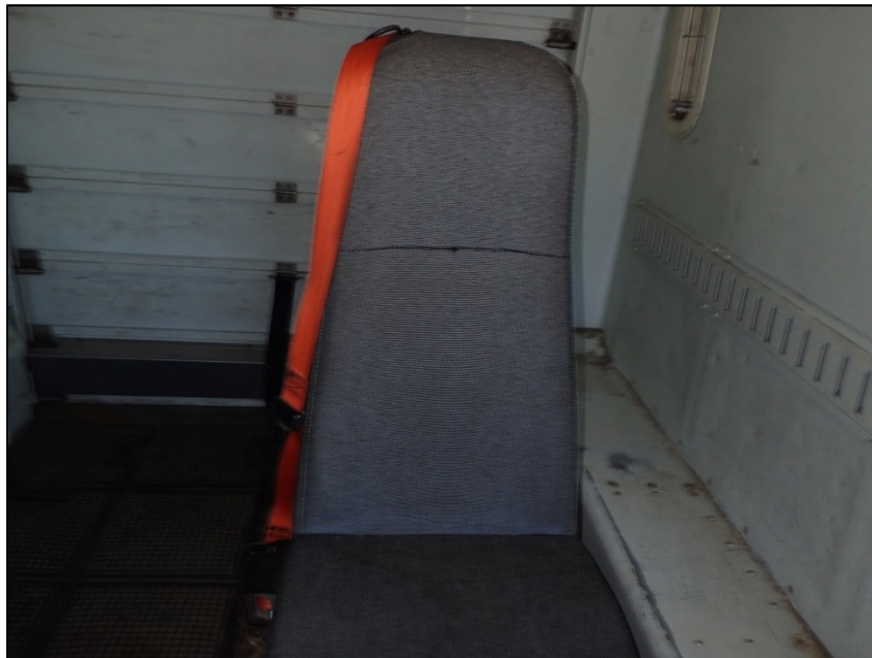
Photograph 6

The cargo area.
